**US Army Corps
of Engineers**

USACERL Technical Report 96/77
July 1996

Investigation of Preapproved Underground Heat Distribution Systems

by
Charles P. Marsh, Nicholas M. Demetroulis, and James V. Carnahan

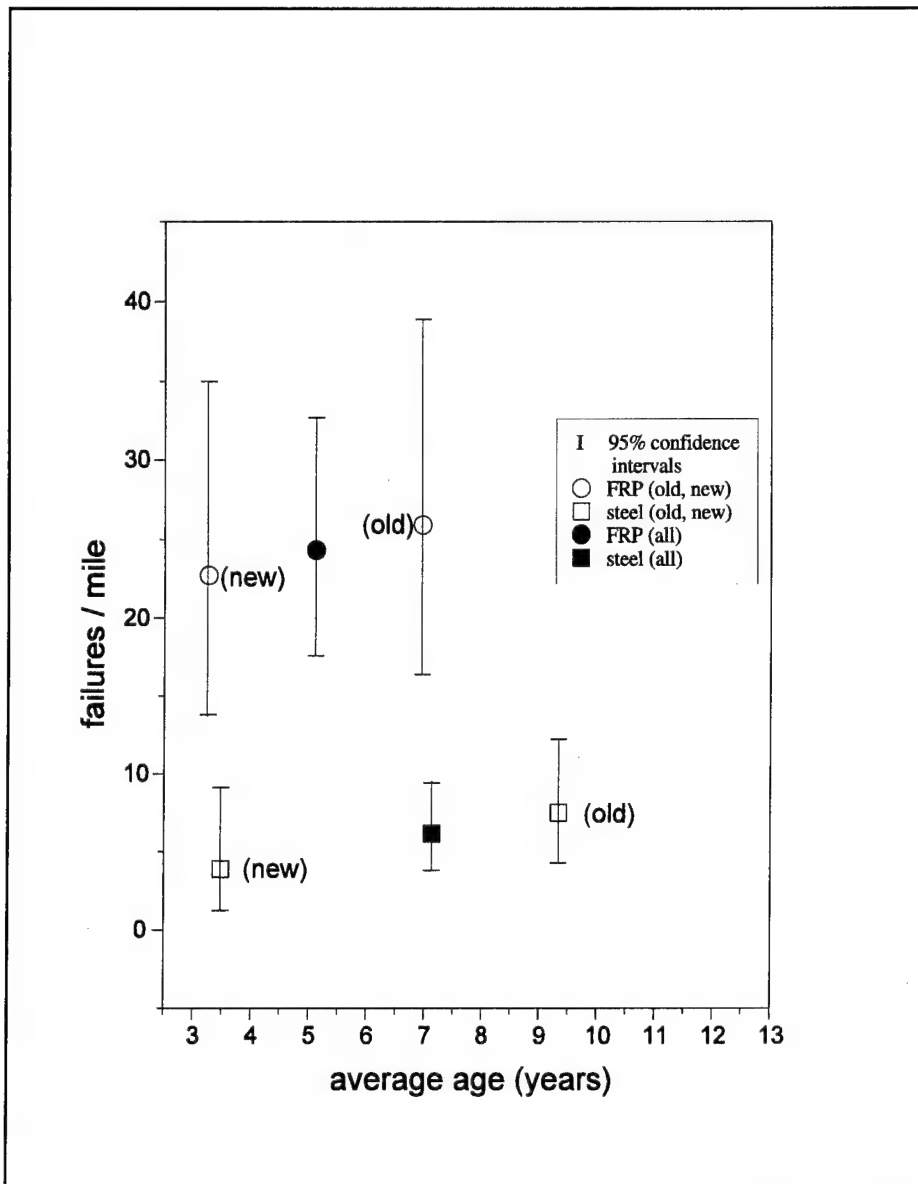
Figure 1a. Failure rates vs. age (Standard I).

However, plotting the results in Tables 11 and 12 may show the general time dependence of the failure rates (Figures 1a and 1b). Accounting for the confidence intervals, the time dependence of the failure rates are not pronounced. The failure rate for FRP conduits appears to decrease slightly as the systems get older. The failure rate for steel appears to increase marginally. However, it would be difficult to call these trends statistically significant.

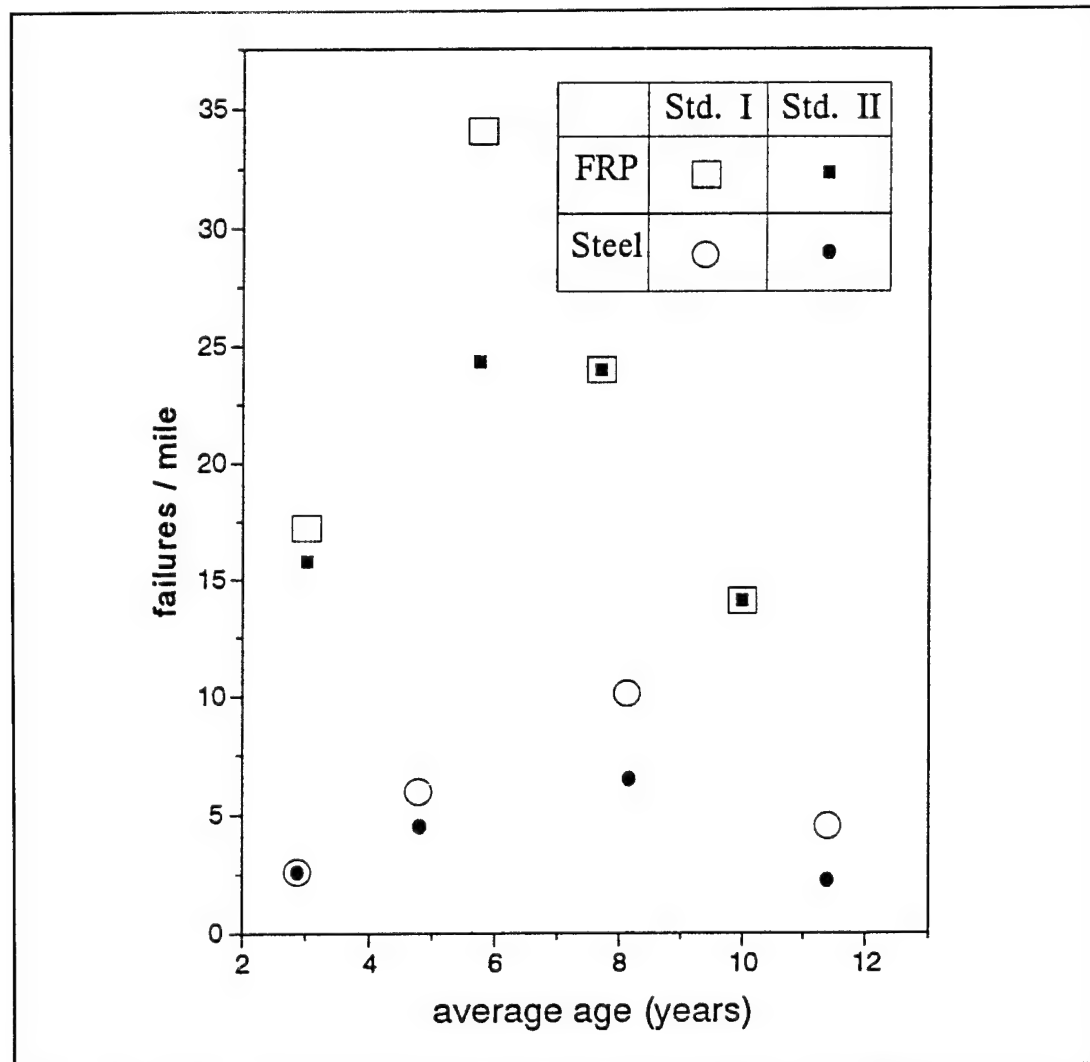
Figure B1. Failure rates versus length-weighted average age for four sequential time periods.

The Pearson correlation coefficient between failure rate and age was found to be quite small ($R^2 \leq 0.1$). A generalized linear model was fit to the data, attempting to explain variation in failure rates with material type (represented by an indicator variable) and

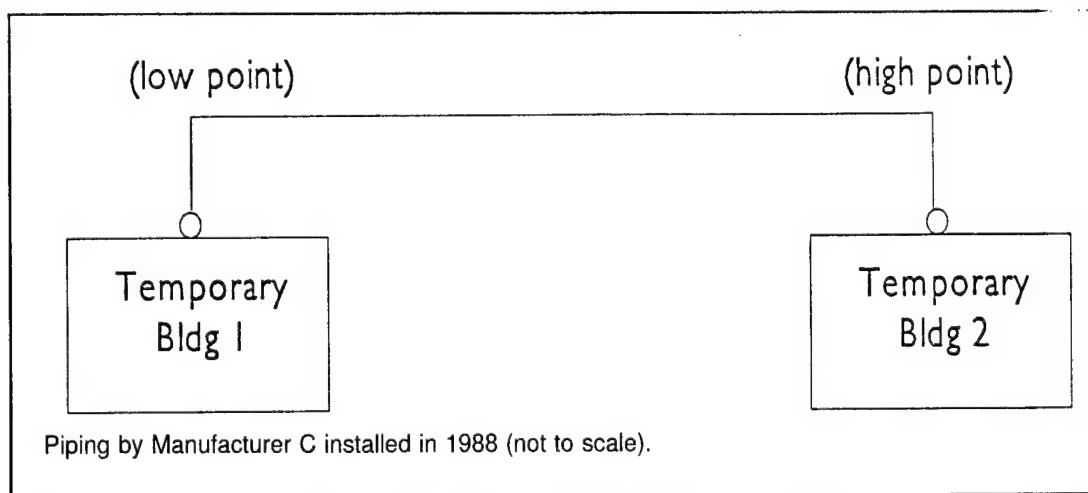
Figure D2. Schematic diagram of System 4 at Wright-Patterson AFB, OH.

This system consists of piping from Manufacturer C and has a steel conduit (Figure D2). It was installed in 1990 under contract No. F33601-89-CW027. The project consists of steam and condensate lines contained in a single conduit. It ties into an

overhead system, feeds two temporary buildings along "L" street and extends approximately 600 ft. On the lower half of the system, the route of the conduit and expansion loops were clearly defined by dried grass over the buried conduit.

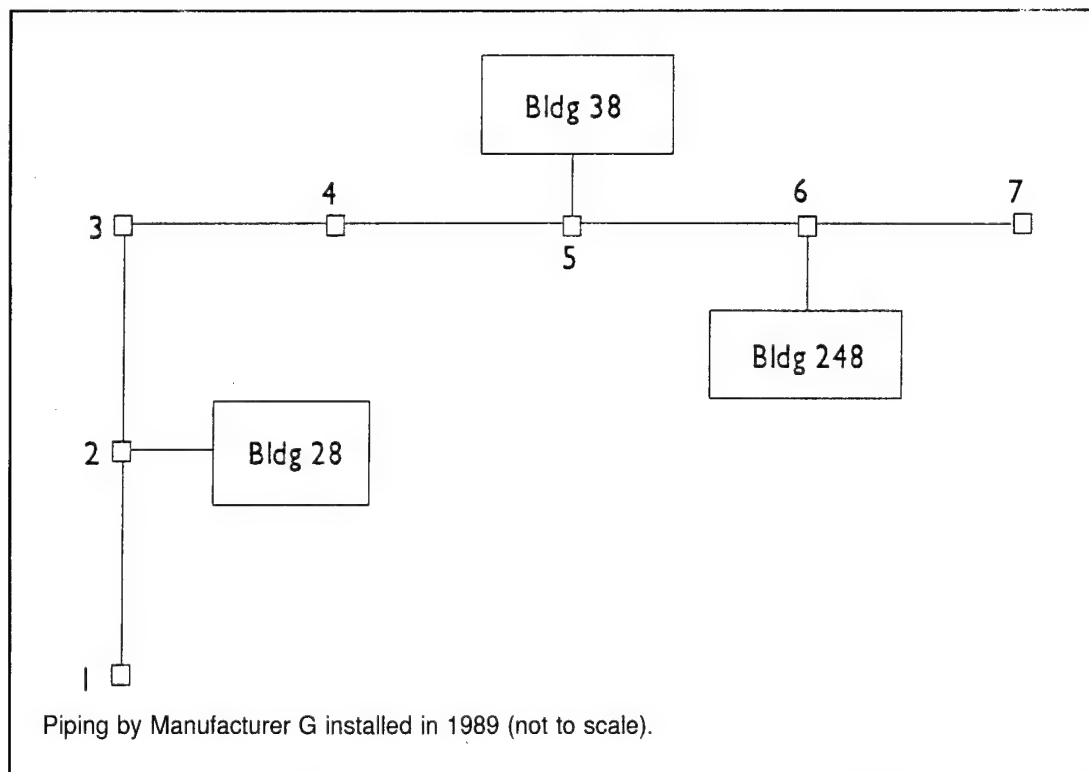
Figure D3. Schematic diagram of System 5 at Wright-Patterson AFB, OH.

This system consists of piping from Manufacturer G and has an FRP conduit (Figure D3). Drawing WP-43-7 for the project was dated May 1989. The contract involved replacing condensate lines using new vinyl ester resin conduits and steam lines

encased in conduits of the old polyester resin. The "L"-shaped system runs parallel to Buildings 28 and 38. It then makes a right angle to run along the end of Building 28. Manholes 6 and 7 were in a construction zone and were inaccessible.

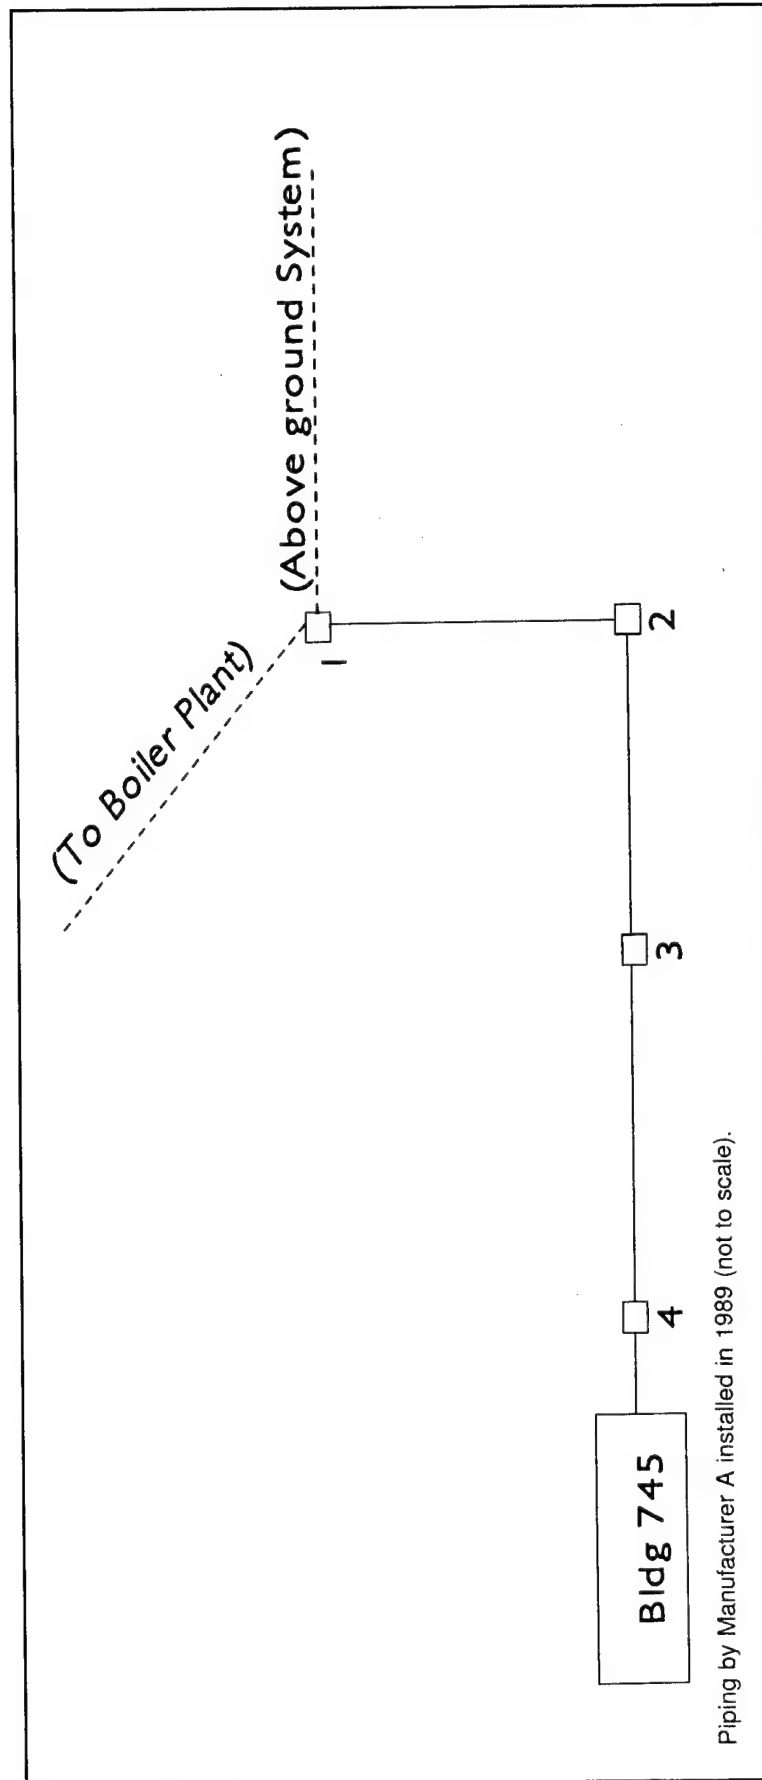
Figure D5. Schematic diagram of System 7 at Wright-Patterson AFB, OH.

8. Detailed Inspection of System #7—This system consists of piping from Manufacturer A and has a steel conduit (Figure D5). The 1989 project was designated WP 54-8, FAC. 07199, and PCF1939. The piping was at the base of a long sloping hill.

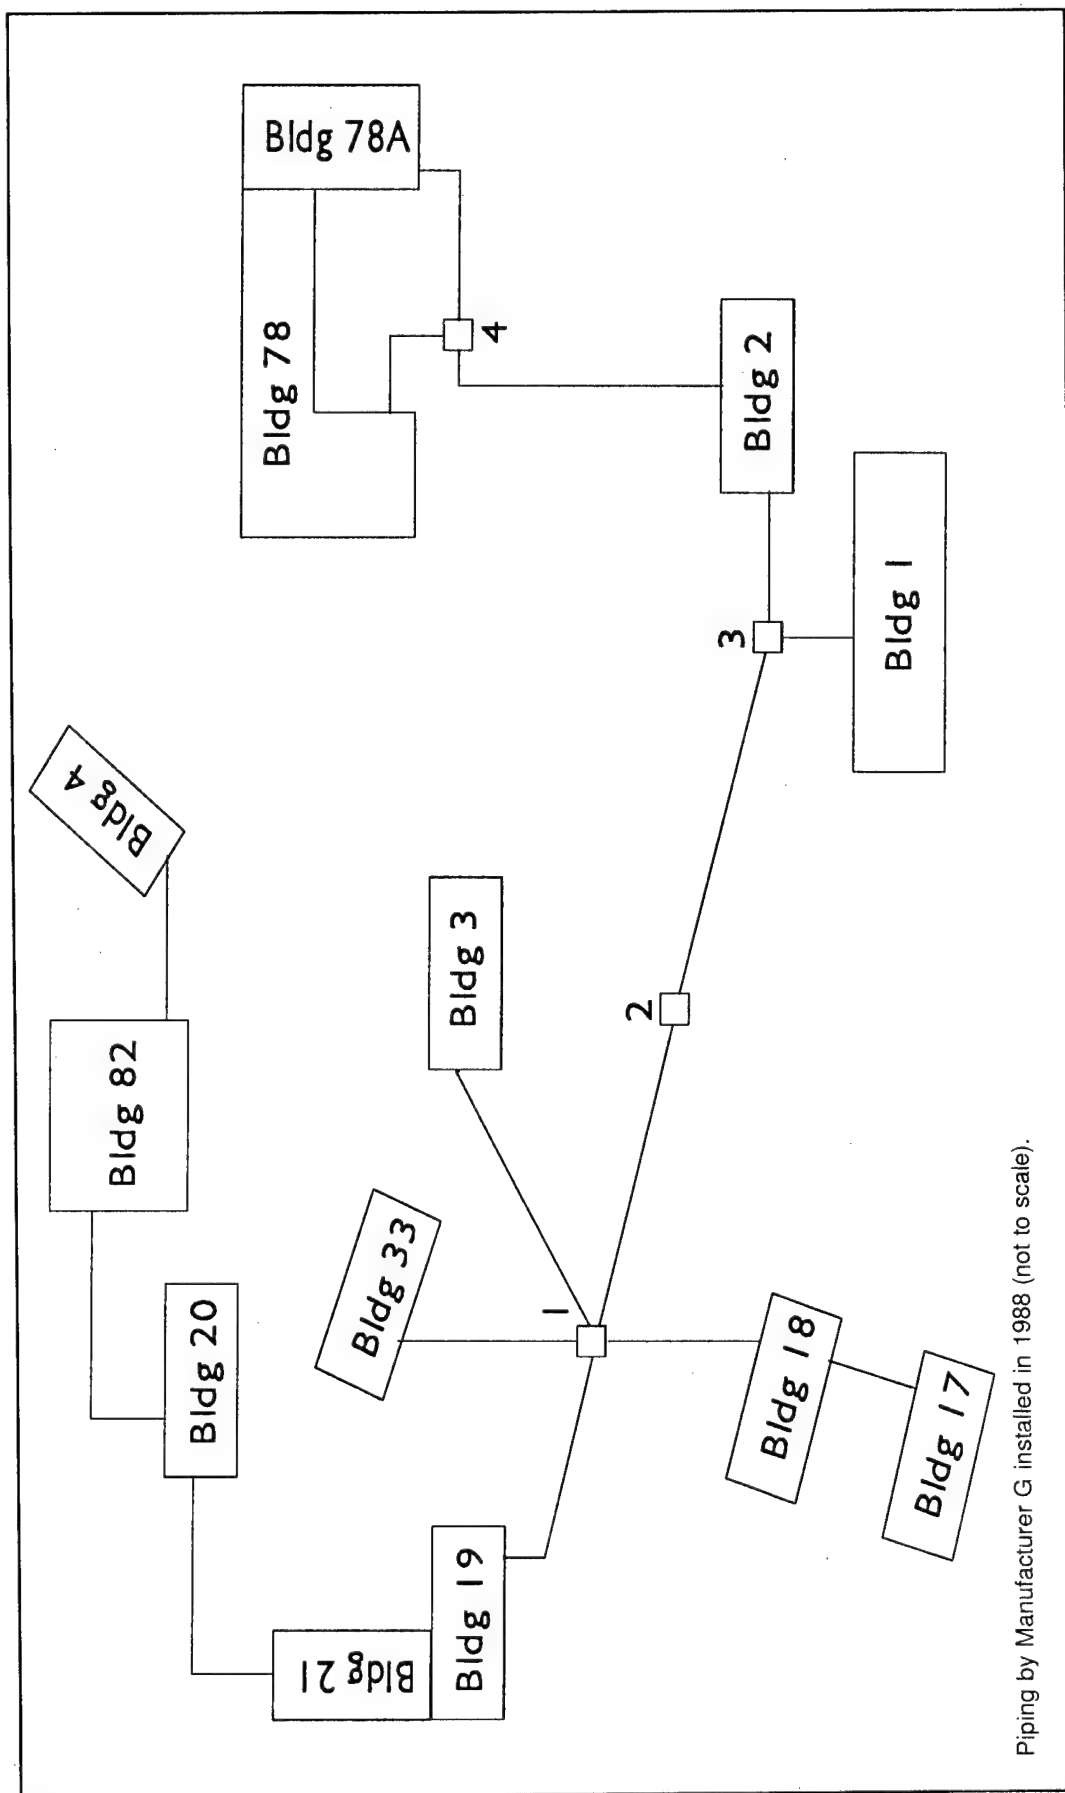
Figure E2. Schematic diagram of System 9 at VA-Bedford, MA.

a. Manhole 1—This manhole was round with an 8-ft diameter, was 11-ft deep, and was a solid concrete top design with a steel access cover. No sump pump or means for ventilation were provided. One ladder rung was missing. A drip type leak was observed at the condensate conduit coming from Building 19, and 4 in. of standing water was present in the manhole. None of the ten casing vents was steaming. All conduit penetrations were caulked and all end plate assemblies contained gland seals.

b. Manhole 2—This manhole was 4 ft × 5 ft × 4 ft deep and was a solid concrete top design with a steel access cover. No sump pump or means for ventilation were provided. The manhole was dry, and no steaming was observed from four conduit

vents. All conduit penetrations were caulked and all end plate assemblies contained gland seals.

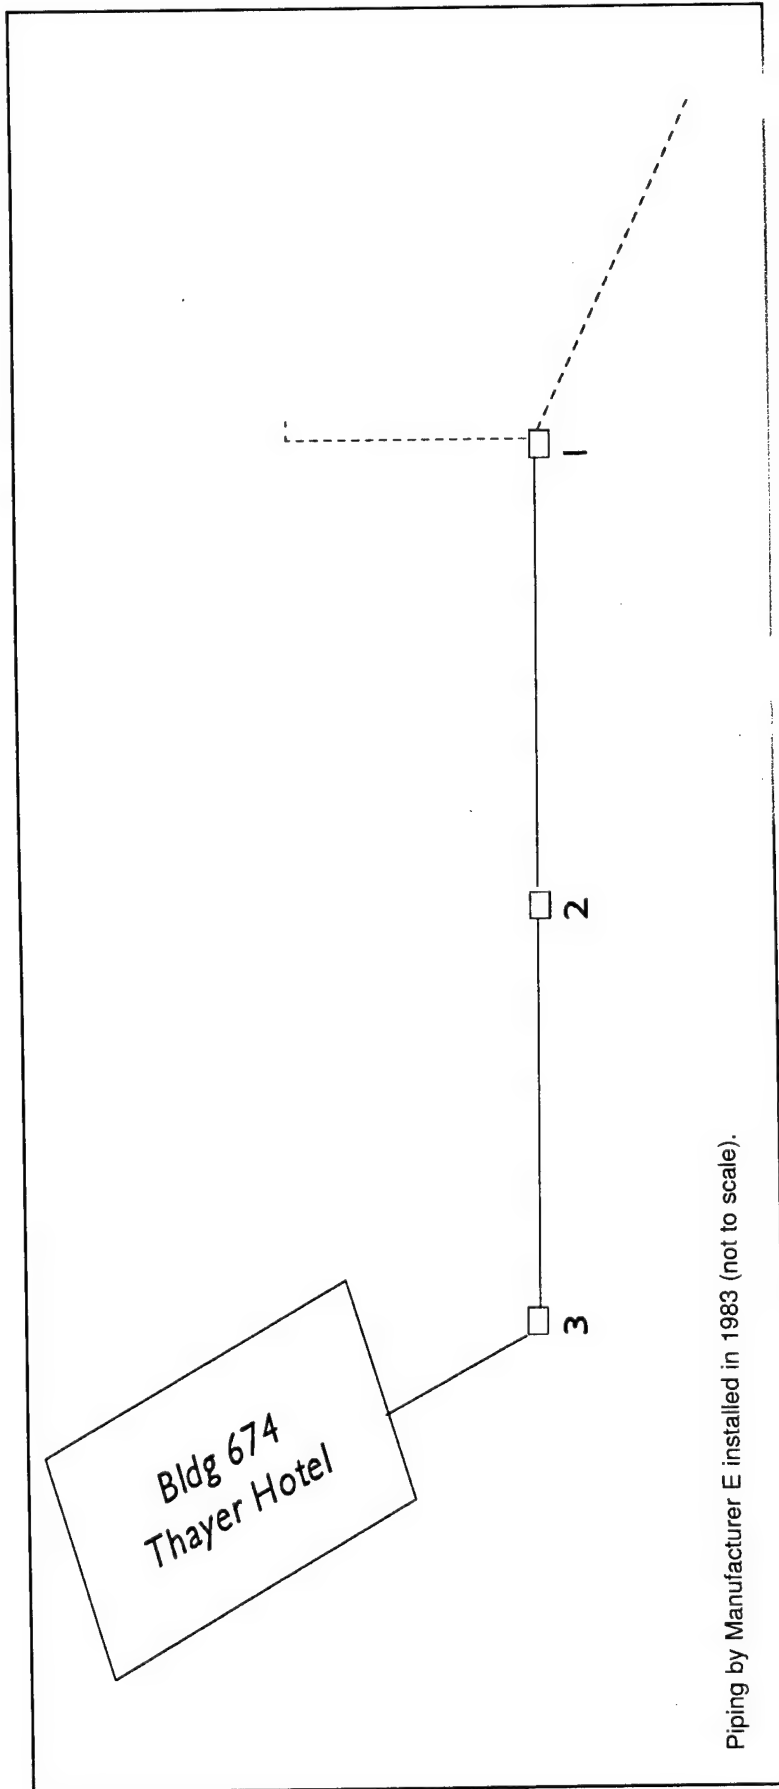
Figure F1. Schematic diagram of System 10 at USMA, West Point, NY.

a. Manhole 1—This manhole was 18 ft × 12 ft × 8 ft deep, was of the solid concrete top design, and had two 3 ft × 2 ft steel plate access hatches. The manhole was served by a steam ejector type sump pump. Steaming was observed from a 6-in. manhole vent pipe. This steaming was caused by a 1-in. discharge line from pressure regulating station relief valves being routed out of the vent pipe. The manhole was dry. Wall penetrations consisted of neatly drilled holes in the manhole walls for the installation of link seals between the conduit casings and the concrete. No conduit vents or drains were observable on runs from Manhole 2 because the end plate assemblies were buried outside of the manhole.

b. Manhole 2—This manhole was 6 ft × 9 ft × 8 ft deep, was of the solid concrete top design, and had a 3-ft-diameter steel manhole cover and an 18-in. steel covered

inspection port. No sump pump or means for ventilation were provided, and 3 in. of standing water was present. Link seals were used between the end plates and the heat carrying pipes. The conduit vents and drains were 3/4-in.-diameter instead of the required 1 in. The drains were fitted with check valves that did not function properly in this application after a time. None of the five conduit vents were observed to be steaming. Three drains were checked and were dry.

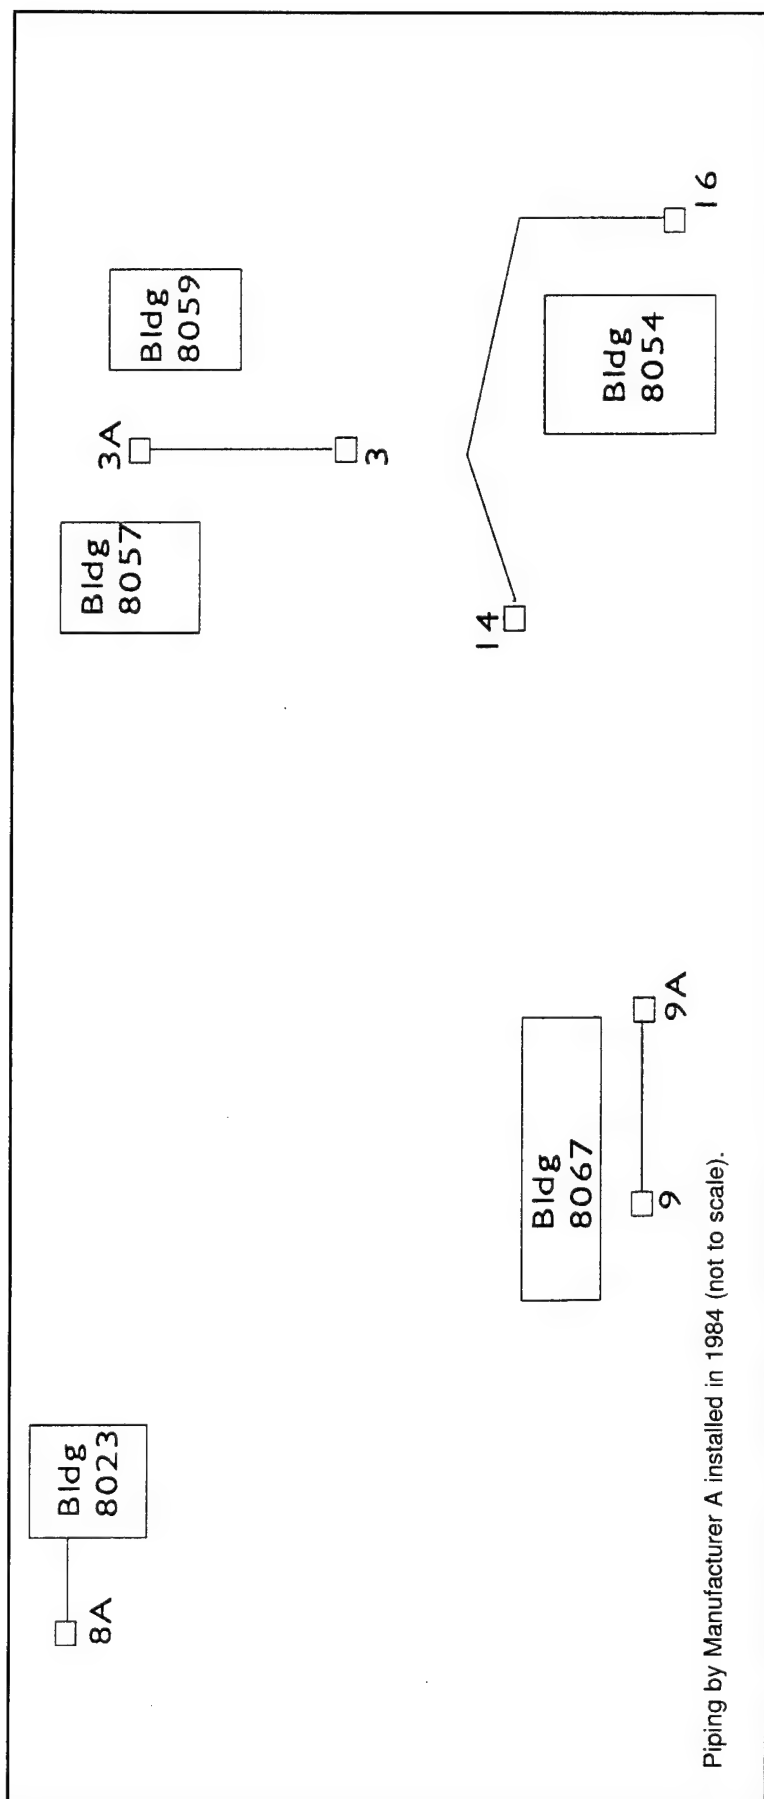
Figure G1. Schematic diagram of System 12 at Fort Riley, KS.

This system consists of piping from Manufacturer A and has a steel conduit (Figure G1). The piping was installed in 1984 and is in the Custer Hill area. Approximately 95 percent of the piping contains both steam and condensate in a common conduit. Cathodic protection has been provided, but many of the isolating flange gasket kits are incomplete. The manhole penetrations for the conduit are sealed only with caulking material.

a. Manhole 3—This manhole was 6 ft x 6 ft x 13 ft deep and was a raised top design with steel plate covers. The transition from a shallow trench system in one wall was made to buried conduits to the other three walls. Each conduit contains both steam and condensate piping. The end plate of the conduit from Manhole 4 was recessed into the manhole wall. All end plates showed minor general corrosion. The manhole was dry, and the sump pump was functioning properly. No evidence of water or steam in the conduits was found.

b. Manhole 3A—This manhole was 6 ft × 6 ft × 9 ft deep and was a raised top design with steel plate covers. All three conduits contained both steam and condensate lines. Each manhole penetration was sealed with caulking material that was badly deteriorated. The manhole was dry, and the sump pump was functioning properly. The dielectric isolation kits on the flanged take offs to Buildings 8057 and 8059 were incomplete. The isolating washers on the flange bolts were missing though steel washers were present.

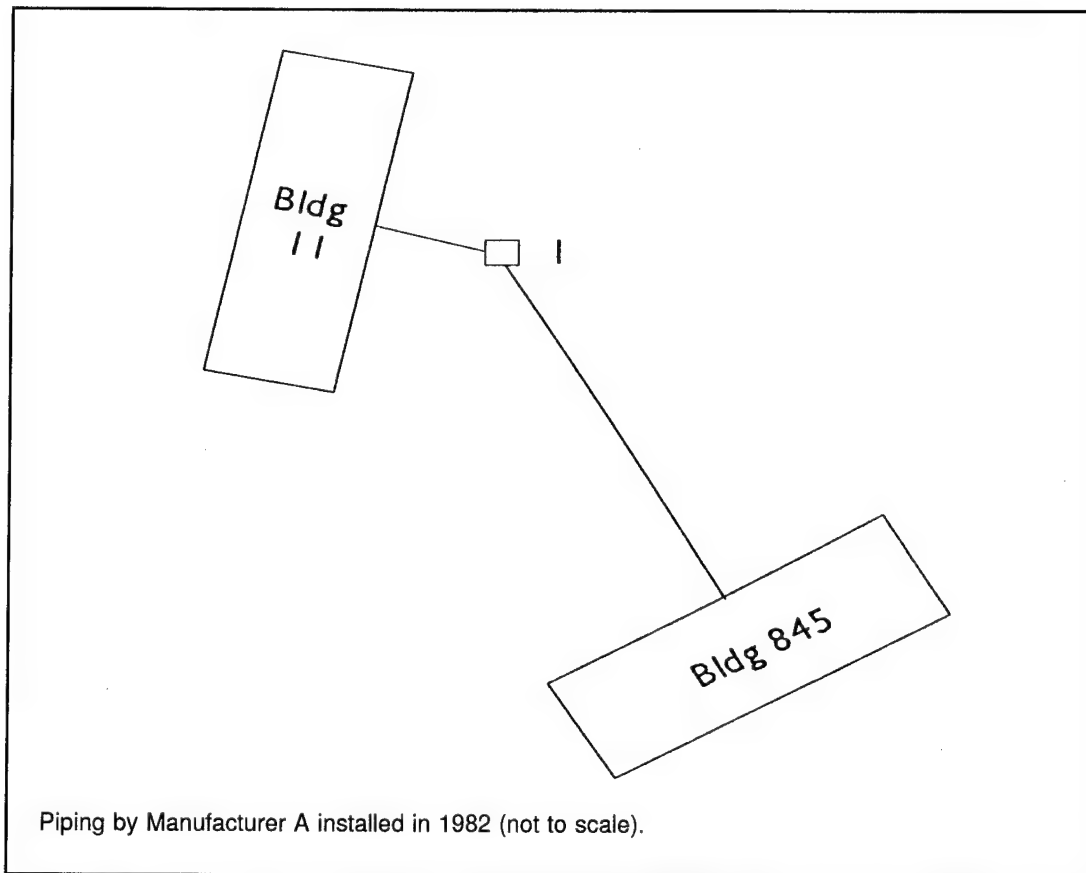
Figure I1. Schematic diagram of System 14 at Jacksonville NAS, FL.

This system consists of piping from Manufacturer A and has a steel conduit (Figure I1). The project, designed in 1982 by Architect-Engineer Evans and Hammond of Jacksonville, FL, was "Replacement of Steam Condensate Lines," Construction Contract N62427-2514 (Spec. 06-82-2514). This system is above ground except for street crossings and for service to Buildings 11, 845, and 855. Manholes were not provided at street crossing segments.

a. Transition Southeast of Building —Two side-by-side manholes are at the point where the above ground system transitions to below ground. Manhole A (7 ft x 7 ft x 5 ft deep) appeared to be part of an older system that was in use prior to 1983. The manhole top was covered with removable steel plates with no manhole vents. The manhole contained no sump pump and was dry. A 6-in. steam line and a 4-in. condensate line exited the manhole through a buried concrete trench. Maintenance personnel indicated that the 4-in. line has been abandoned and that the 6-in. line was being used for condensate return. The temperature of the 6-in. line was 170 °F. There

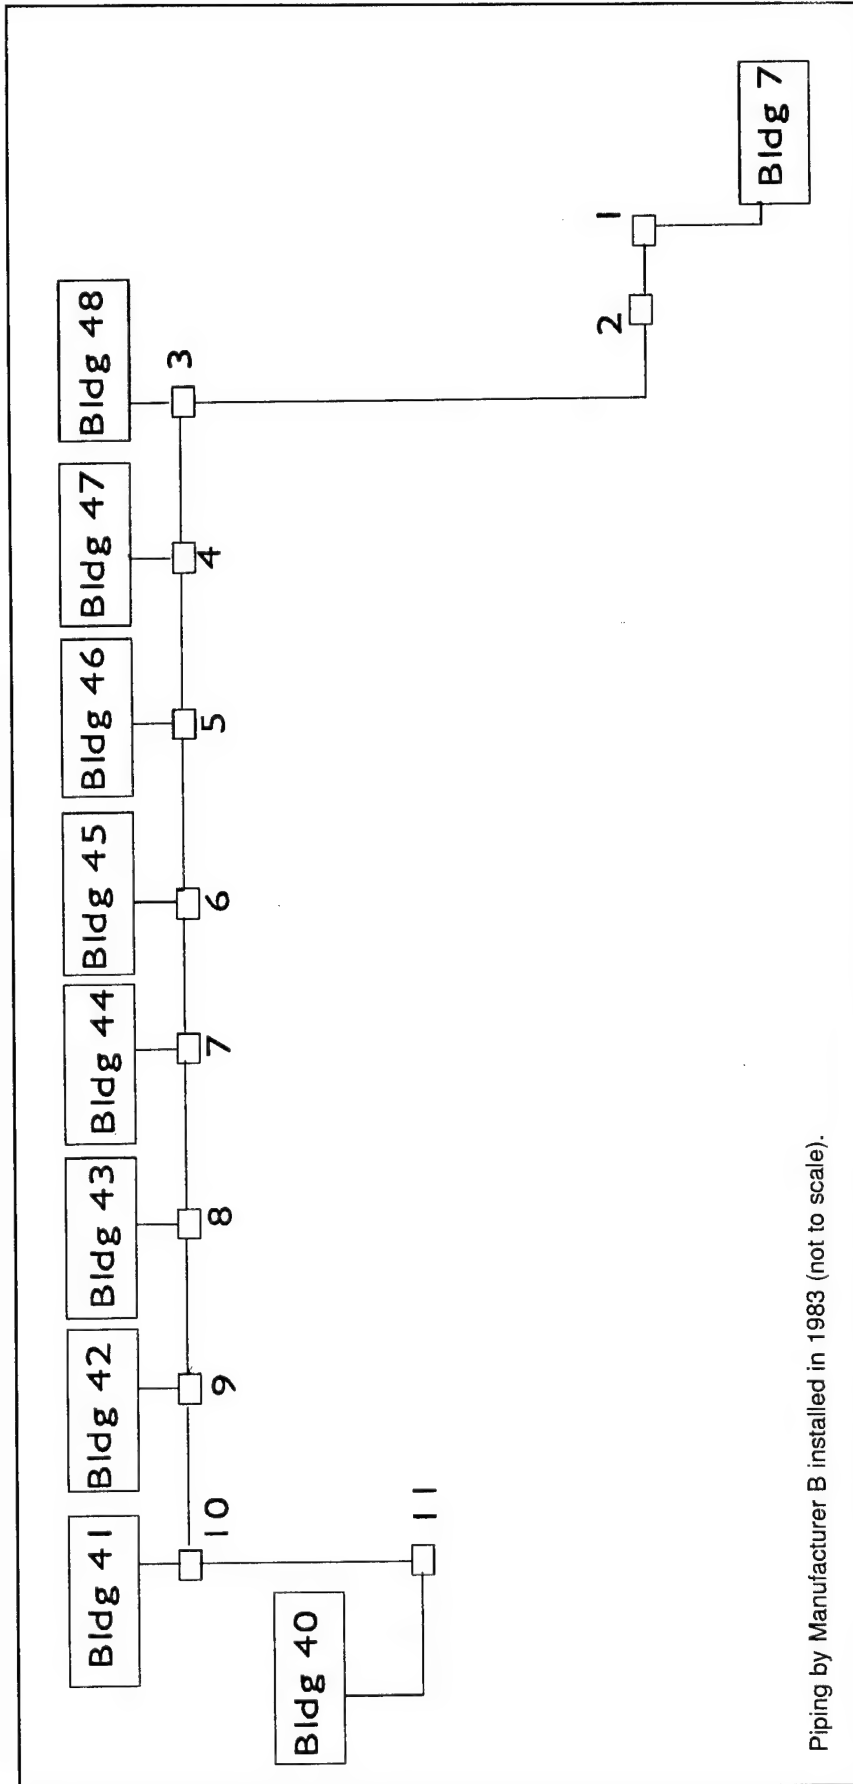
Figure J1. Schematic diagram of System 20 at Mayport Naval Station, FL.

a. Manhole 1—This manhole was 8 ft × 5 ft × 10 ft deep and was northwest of Building 7. The manhole had removable heavy steel plate tops with no manhole vents. No entry ladder was installed. Water in the manhole indicated that the steam jet sump pump was not operational. The 6-in. steam line was contained in a 13-in. conduit. A gland seal was installed at the conduit end plate. The manhole was extremely hot and could not be entered.

b. Manhole 2—This manhole was essentially identical to Manhole 1.

c. Manhole 3—The conduit run from Manhole 2 was approximately 1,200 ft under a street and a large paved area. The manhole top consisted of two heavy steel plates with no vent pipes located below grade. The manhole walls did not extend above grade and surface water tended to collect in the depression. The manhole was steaming heavily and could not be opened for inspection.

d. Manholes 4 Through 10—These manholes were installed in a line approximately 150 ft apart and serve HSL Buildings 40 through 48. All of the manholes were about 6 ft × 6 ft and 5- to 7-ft deep. Each had removable heavy steel tops with no manhole vent piping. No access ladders were installed and sump pumps, if present, were not operational. All of the manholes were steaming heavily and severe corrosion was observed at conduit end plates, casings, and other manhole internals. Essentially no pipe insulation remained on any of the piping. Manholes 5 and 7 had leaks in the steam piping or fittings. In Manhole 6, water had covered the supply piping and was boiling vigorously. At Manhole 9, the conduit casing had corroded through completely leaving the conduit open for water intrusion.

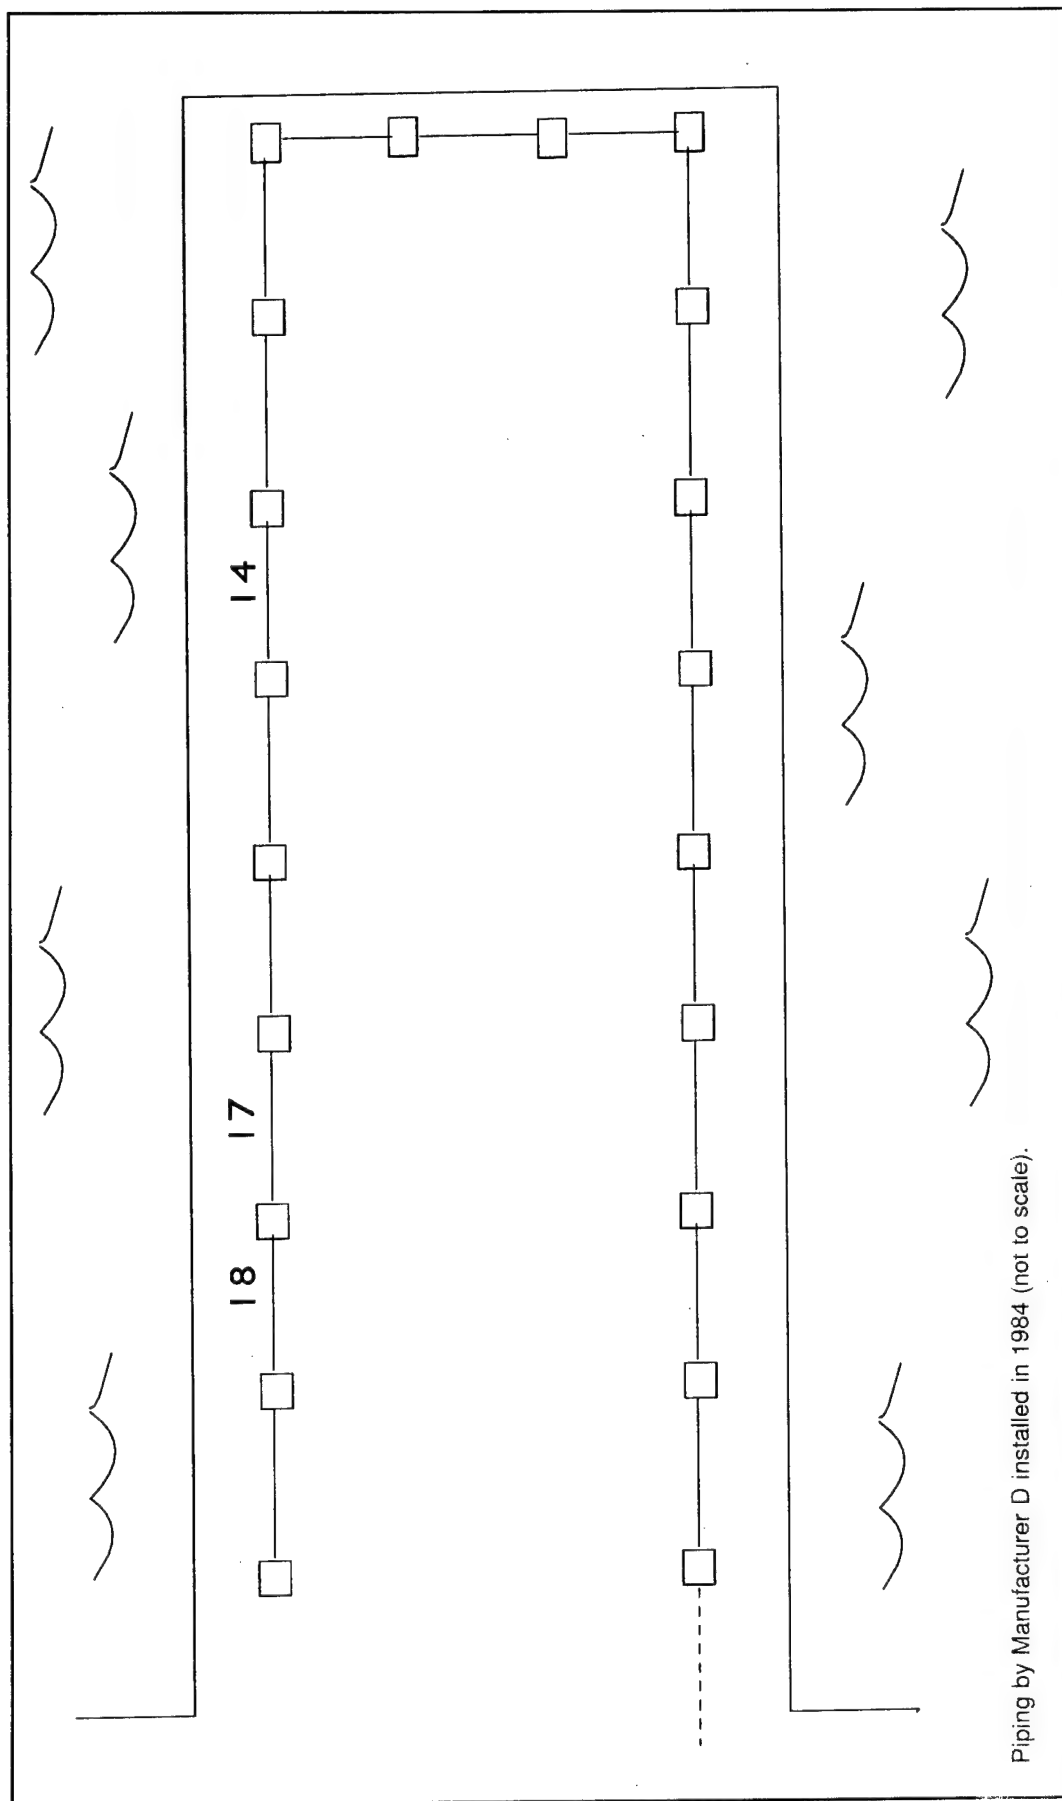
Figure K1. Schematic diagram of System 22 at Charleston Ship Yard, SC.

a. Pressure Test of Conduit Section 18—This conduit section was 226 ft long. Air pressure was initially applied at 3:00 PM. Significant air leakage occurred at both gland seals. One gland seal was effectively tightened, while the other seal had a broken bolt and a second bolt that could not be reached. Some leakage remained at the latter gland seal. The conduit was again pressurized and valved off at 3:12 PM. The pressure readings and times observed were:

3:12 PM	— 15.0 psi
3:17 PM	— 14.2 psi
3:22 PM	— 13.1 psi
3:27 PM	— 12.3 psi
3:32 PM	— 11.5 psi
3:37 PM	— 10.0 psi
3:42 PM	— 9.3 psi
3:47 PM	— 8.1 psi

b. Pressure Test of Conduit Section 17—This conduit section was 158 ft long. The conduit and end plate coatings were in excellent condition. No steaming or moisture occurred at the vent and drain at the higher elevation. At the lower elevation, a large quantity of water was drained from the conduit. The manufacturer's representative theorized that this moisture had been absorbed by the calcium silicate insulation, was later driven off when the system was energized, and then condensed in the conduit casing. The conduit was pressurized to 15.5 psi and valved off at 9:27 AM. The pressure readings and times observed were:

c. Pressure Test of Conduit Section 14—This conduit section was 142 ft long. Some cracking and spalling of the casing coating exposed uncoated fiberglass. Considerable peeling of the coating was evident at the welded juncture of the end plate and the casing. The manufacturer's representatives indicated that this was believed to be a field patch rather than a factory fabricated section. A water mark on the concrete trench wall indicated that this section was submerged for some time. The conduit was initially pressurized at 10:15 AM but could not hold pressure because of leaks at the gland seals. The seals could not be completely tightened and air could be heard escaping during the test. The pressure readings and times observed were:

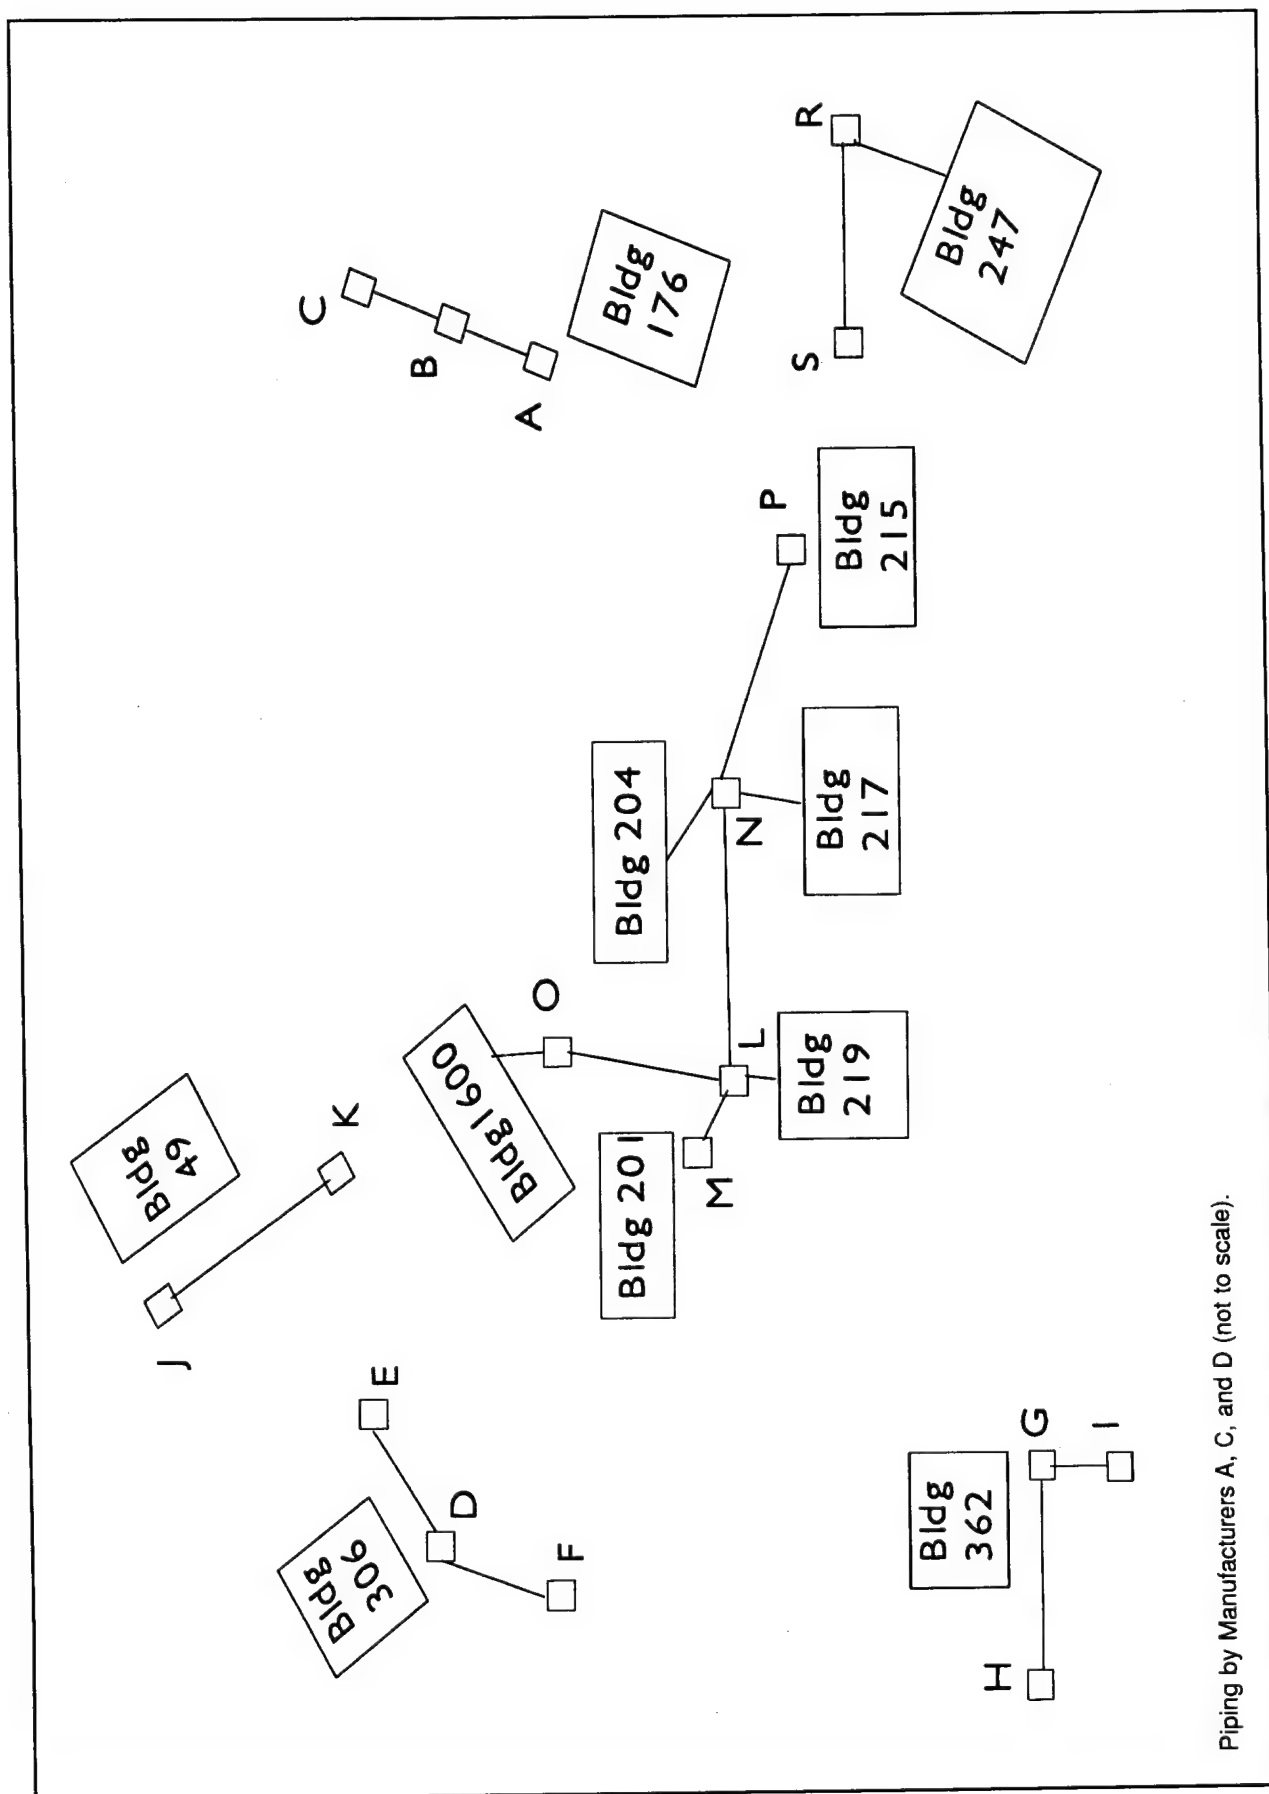
Figure L1. Schematic diagram of System 23 at Charleston AFB, SC.

a. Pressure Test 1—This conduit, installed in 1988, was supplied by Manufacturer C and had a steel conduit. The total run was about 350 ft. This new system was spliced into an old system (Manufacturer D) as a means of repairing a failed system. The design of the buried interface could not be determined. No air pressure build up was observed when compressed air was applied. Aside from the fact that a buried connection was made, no conclusions could be drawn from this test.

c. Pressure Test 3—This conduit was installed in the middle 1980s, was supplied by Manufacturer A, and had a steel conduit. The conduit was 106 ft long and extended from Manhole B, described above, to a prefabricated steel manhole, Manhole C, 9 ft in diameter and 12-ft deep. The steel manhole was dry and contained an electric sump pump. The 6-in. line was contained in a 14-in. conduit, which was pressurized to 15.5 and valved off. The pressure readings and times observed were:

10:13 AM — 15.5 psi
10:18 AM — 15.0 psi

10:23 AM — 15.0 psi
10:28 AM — 14.8 psi
10:33 AM — 14.7 psi
10:38 AM — 14.6 psi
10:43 AM — 14.5 psi

e. Pressure Test 5—This conduit was installed in 1985, was supplied by Manufacturer A, and had a steel conduit. The conduit length was 325 ft and ran south from Manhole D (previously described) to Manhole F. The 2-1/2-in. carrier line was contained in an 8-in. conduit. Manhole F was in a parking area and was 9 ft × 9 ft × 8 ft deep. The concrete top contained a 30-in. square access hatch. This manhole was dry and was served by an electric sump pump. The wall penetration was cemented and caulked. The drain plug was missing from the conduit end plate. The conduit was pressurized to 15.5 psi at 11:25 AM, and no pressure drop was evident at 1:40 PM.

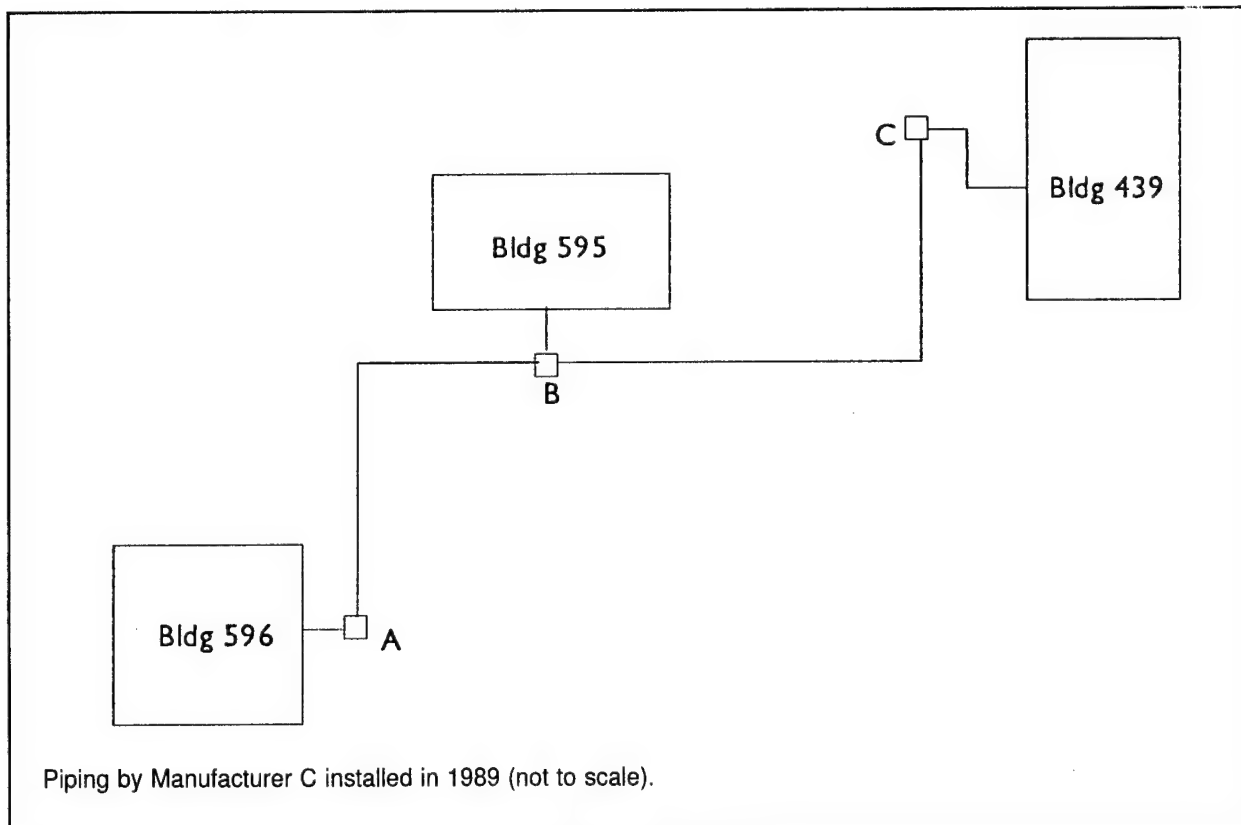
Figure M1. Schematic diagram of System 24 at Grissom AFB, IN.

This system consists of piping from Manufacturer C and has a steel conduit (Figure M1). It was installed in 1989.

a. Pressure Test 1— This section extended 20 ft from Manhole A to a pit in the equipment room of Bldg. 596. The concrete manhole was 5.5 ft × 5.5 ft × 6 ft deep, extended slightly above grade and had a solid aluminum plate cover. No access ladder was present and a steam valve gasket had a slight leak. Six in. of water in the manhole was drained after adjusting the float mechanism on the sump pump. The conduit wall penetrations were caulked and cemented. No vapor was evident at the steam line casing vent, but a light dripping was noted at the drain opening. Gland seals were installed at the end plates both at the manhole and the building pit. Building pit dimensions were 4 ft × 4 ft × 5 ft deep. The steam line casing was 10-3/4 in. in diameter and contained a 3-in. pipe.

Pressure was applied to the casing at 10:00 AM to 15 psi. Pressure immediately dropped when the line was valved off due to leakage at the gland seals. The gland seal at the manhole was tightened and the system repressurized with the same results because of a gland seal leak at the building pit. This pit could not be entered because of a leaking flange gasket on the steam line. At this point the pressure test was abandoned.

(2) Pressure Test 3 (Steam Supply)—The steam line casing vent was plugged. While opening the vent, steaming was observed, and the plug was retightened. The conduit temperature was 320 °F, which indicates an internal pipe leak. Assuming a 320 °F steam temperature, the conduit casing was pressurized to at least 75 psi. This section was valved off for about an hour and the casing temperature dropped to 270 °F. Upon reactivation, the casing temperature again rose. No attempt was made to pressurize this conduit.

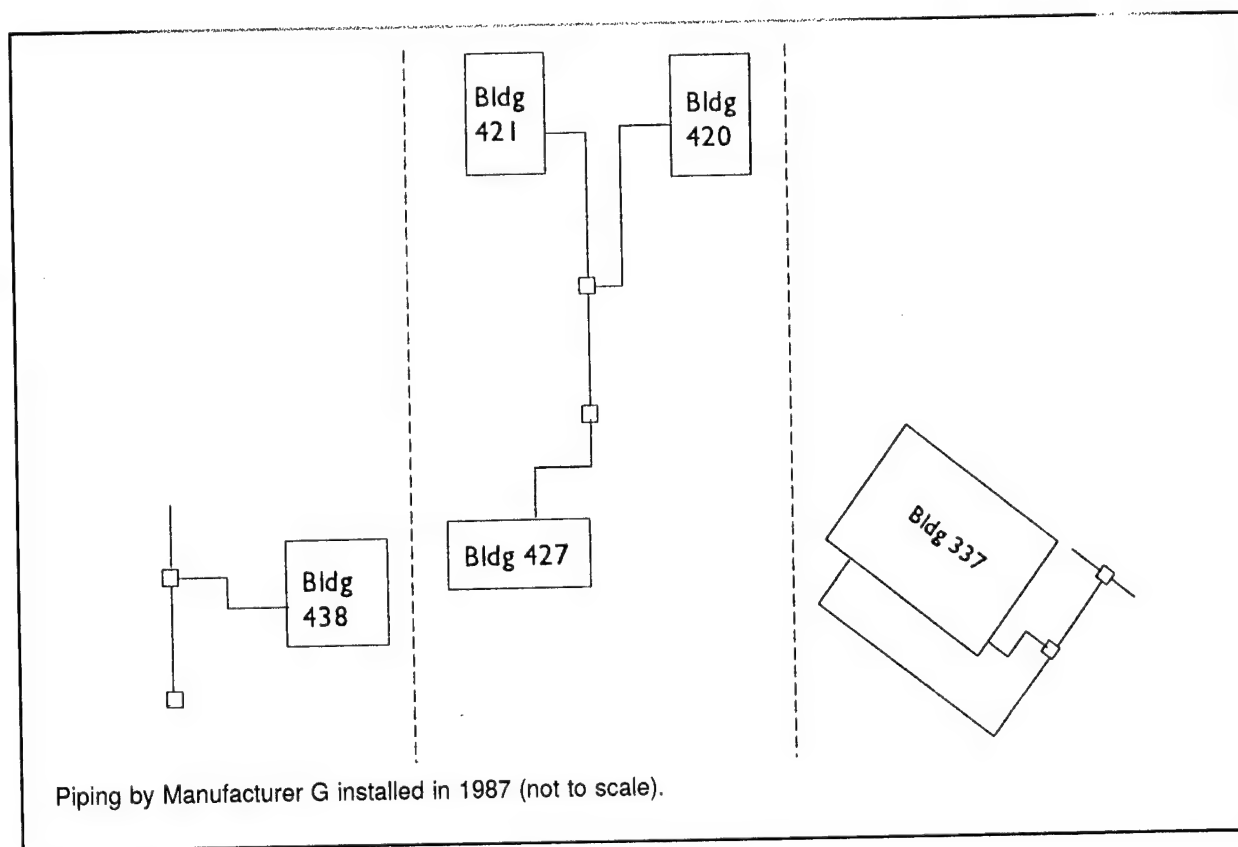
Figure M2. Schematic diagram of System 25 at Grissom AFB, IN.

b. Pressure Test 3—Conduits extend 200 ft from Manhole E at northwest corner of Bldg. 427 to Manhole F feeding Bldgs. 421 and 420. Both manholes were concrete with solid plate aluminum covers and caulked and cemented conduit wall penetrations. Manhole E was 10 ft x 5 ft x 10 ft deep, and Manhole F was 10 ft x 5 ft x 8 ft deep. Manhole E had a leak at the steam water ejector. No gland seals were present

at conduit end plates. The 12-in.-diameter steam supply casing contained a 3-in. steam pipe and the 6-in.-diameter condensate casing enclosed a 1-1/2-in. return line.
